Achyut Man Singh

**Abstract:** The irrigation infrastructures in Farmer's Managed Irrigation Systems (FMIS) of Nepal were mostly built from the local materials of mud, stone, and forest products with rudimentary traditional methods, practiced over many centuries. These systems are operated and maintained solely by the community farmers or an individual family. The Nepal Irrigation Sector Project (NISP), funded under the credit assistances of the World Bank, sponsored the modernization of these FMIS in the three western regions of Nepal from 1998 to 2004. The paper gives an account of the infrastructures built under the project to modernize the FMIS, and presents some facts about the impacts of the assistances to FMIS in relieving problems faced by farmers. The structures in the FMIS differ nominally according to the ecological region, due to the terrain and characteristics of the conveyance systems. In the hills, generally, lining and cross drainage structures are common; whereas, in the Terai, it is mostly the headworks structure due to lack of traditional materials as shrubs and forest products. The NISP assisted these FMIS with the participation of the users and their contribut

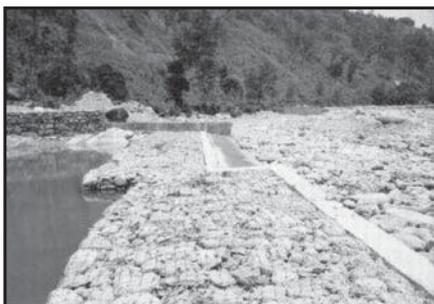
Side Intake at Upallow Dabaki, Kaski

In hill irrigation the experiences of the Department of Irrigation have given many fruitful decisions in this aspect. A general lesson learned is that simple side intake should be constructed in hilly streams that have a steep bed slope and may carry a large debris flow. The river diversion is made of a flexible temporary gabion weir or simple brush wood weir, due to the unpredictable nature of the streams that sometimes degrade or aggrades substantially according to the geological events in its catchments.

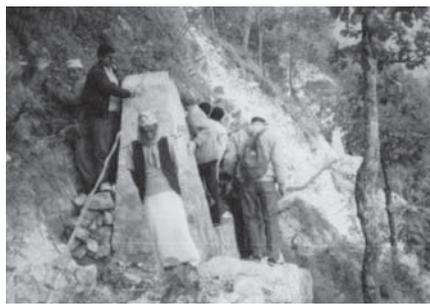
Super passage structure (Typical)

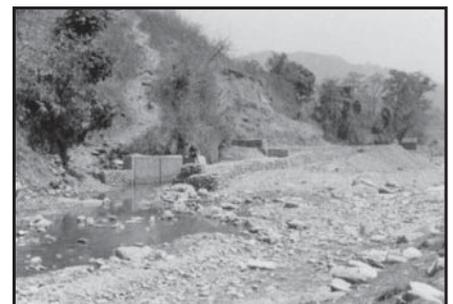
Trash Rack-Tyrolean Weir at Mahendrakot, Kapilvastu District

An example is the Chhangchhangdi scheme of Syangja District, which has failed due to degradation of the river bed. Similar cases are observed at the Arutar irrigation scheme of Gorkha District. Taking lessons from previous failures, intake design is considered as suitable to the site specific. In such cases, trench type headworks have been designed at the Mahendrakot scheme of Kapilvastu District, where the stream was wild and used to carry large boulders in its bed load.

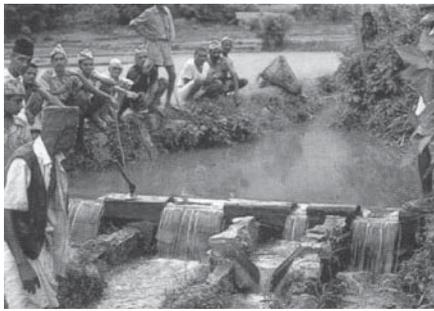
"Sancho" Proportionate Divisor of Raj Kulo of Palpa District

Distribution structures are constructed mostly on the demand of the farmers, as required by their water management practices. The engineers take special care in selecting the structures suitable to match their requirements. In general, proportionate weir divisors are constructed for division among the groups. In the Bhanusera Irrigation system of Tanahun District, the farmers apply rotational distribution among the shareholders of the water utilization system. The main canal is diverted to seven branch canals at a place Satmuhane (meaning 'seven mouths'). The whole flow is diverted into one canal at a time and time periods are allocated for water delivery. The NISP recently built a division structure to allow them to distribute in rotation. Under this category, bifurcation or trifurcation structures, division boxes, and outlets are considered.

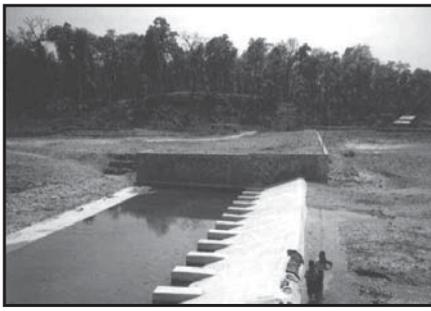
Concrete Weir at Kanchan, Rupandehi

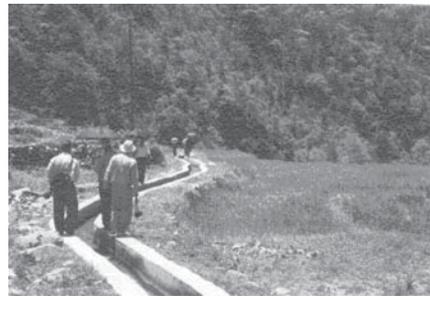
Canal Lining.

Under lining, it is grouped into masonry, concrete lining and HDP pipe use. It has been a general practice in the hills that stone masonry linings are provided to check seepage from the canals. Usually a 10 to 15 cm thick concrete base is prepared and stone masonry walls 20 to 30 cm thick are constructed on the base. For small canal sections this lining method is expensive and also occupies a wide canal width, which is not easily available on hill slopes. In addition, masonry linings generally leak if the cement mortar is not placed in proper way. It has also been observed that cement mortar generally weathers after two to three years of use under water. Maintenance is also critical to the farmers due to unavailability of cement in a few cases. The stone masonry lining is very common and popular among the farmers, however, due to easily available materials (stone and sand) at the sites, and local skill labor is available from the villages.

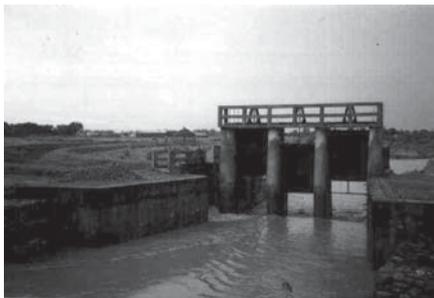
Barrage Structure at Ghagara, Rupandehi District

The NISP in Nepal's western region has endeavored to modernize the FMIS in all the three ecological regions. Under this project the intake types usually adopted are simple side intakes with a temporary diversion weir in hills, and gabion weir or concrete weir in the Terai regions. Two barrage structures also are constructed in Kapilvastu District.

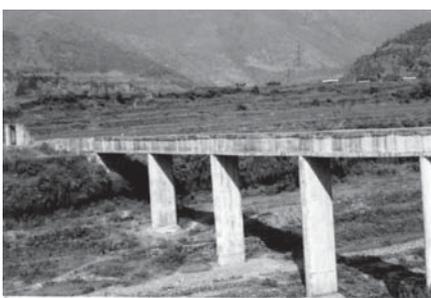
Aqueduct structure at Chapakot, Syangja District

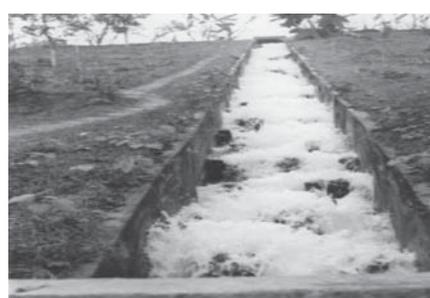
Dented Chute structure at Chapakot

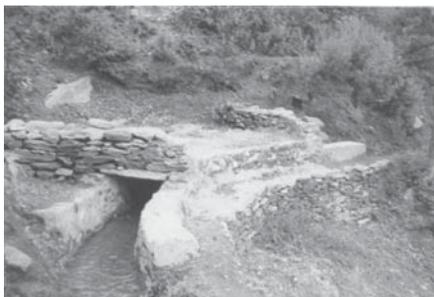
Super passage structure (Typical)
