Minimizing Surface Run-off, Improving Underground Water Recharging, and On-site Rain Harvesting in the Kathmandu Valley

Keshav Bhattarai^{1*}, Ambika P Adhikari²

Abstract

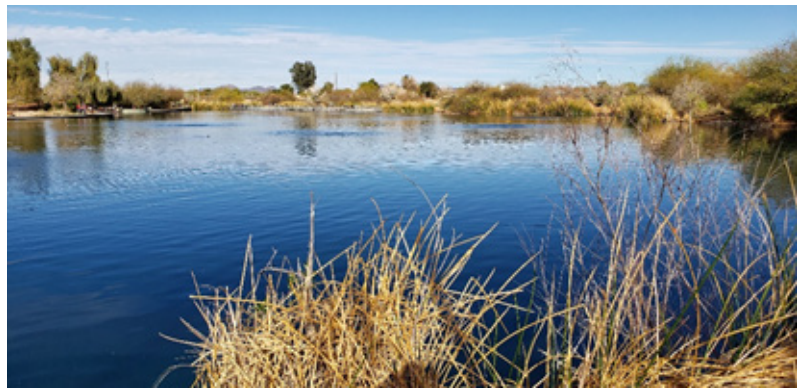
Figure 1. A groundwater recharging pond at Gilbert Riparian Preserve, AZ Tempe, USA. Photo by authors

Natural recharge of ground water in highly built up areas is limited unless there are interferences by human beings. The groundwater recharge can be naturally and passively achieved through retention ponds or recharging ponds (Figure 1).

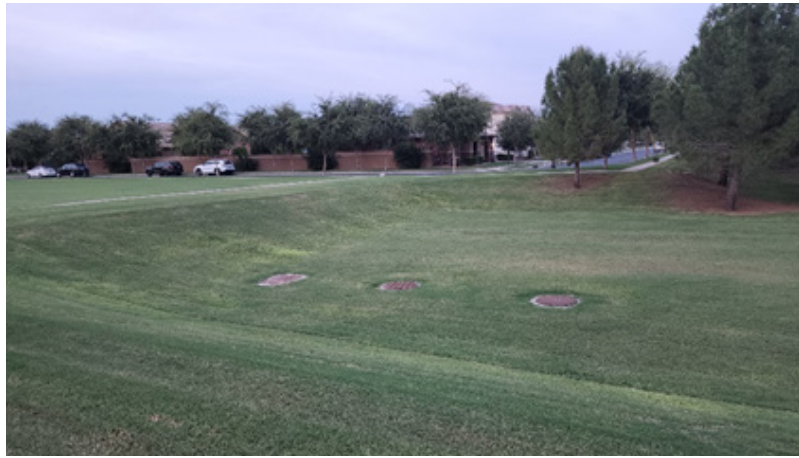
Figure 2. A retention pond in a residential development, Gilbert, AZ, USA. Photo by authors.

developments and residential areas in the USA to avoid flooding of roads and public areas. For example, urbanized residential area in Gilbert, AZ, USA has successfully implemented such a plan of retaining surface water for recharging (Figure 2).

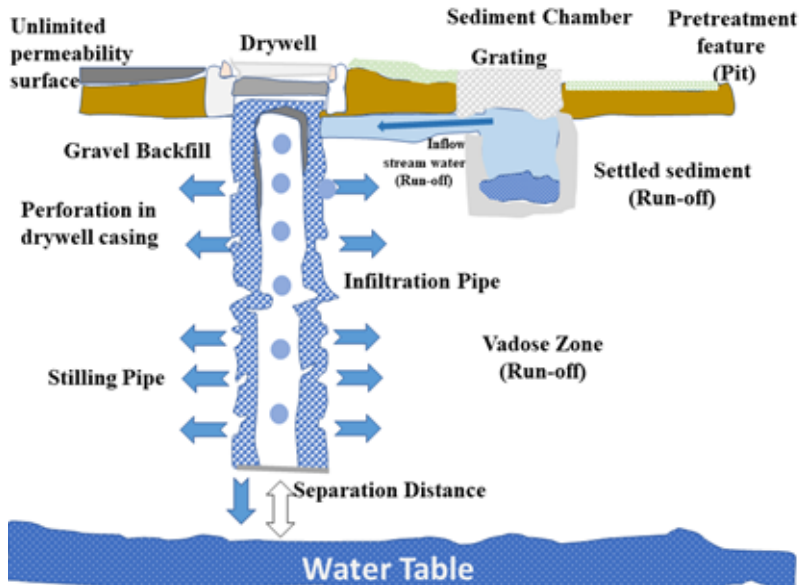
Figure 3. Pit drainage using grass. This drainage system helps seep water underground through dry wells. Drywells are typically backfilled with gravel or cobbles, and water seeps down through walls (Modified and adapted from Edwards et al., (2016)).

inject water into mines, slopes, and tunnels is possible. Pit drainages (Figure 3) are often done both by natural and artificial processes in areas “where drainage and diversion of drainage flow are problematic” (Edwards et. al., 2106). This could be applicable to the culturally modified landscape of the Kathmandu Valley where a poor drainage system often causes floods during heavy rainfall. Pit drainage could help deflect and redirect flood water. Nature-based processes such as the retention ponds or recharging ponds take a long-time to stabilize the water levels because they work slowly and gradually through seepage and filtration depending upon the geotechnical and environmental conditions of area. By contrast, the mechanical deep-water injection is quick and efficient. However, the deep-water injection requires external energy, hardware, and other tools and human resources. On the other hand, natural recharging processes as described above are passive and work through gravitation, requiring only an initial construction and dedication of land for this purpose.

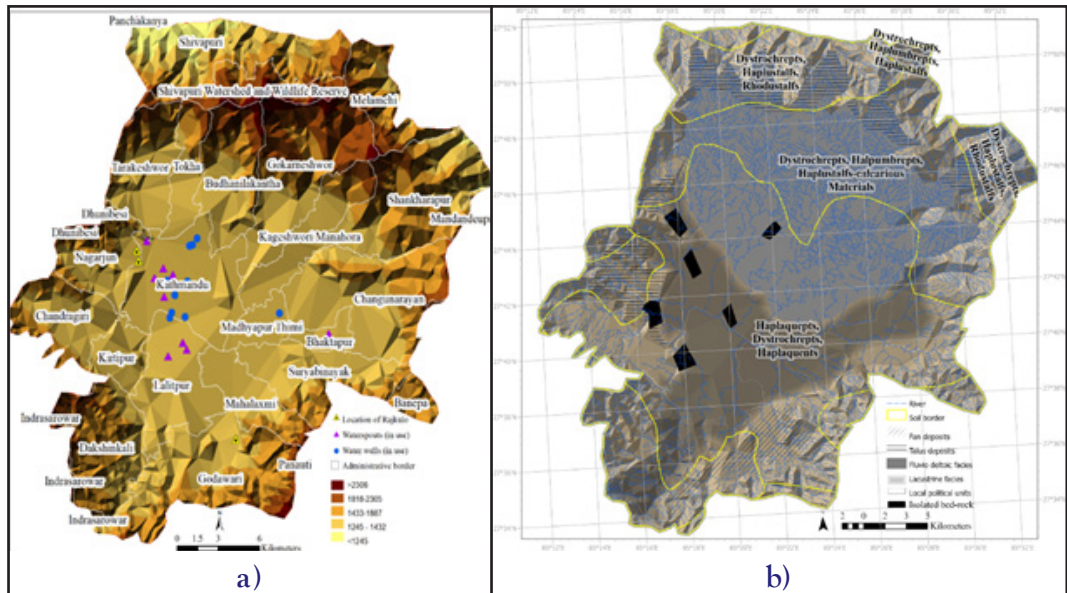
Figure 4. Kathmandu Valley (a) Landscape; and (b) major soil types

(1300-1923) that constructed various Qanat tunnels to avoid contamination and minimize rapid evapotranspiration, and evaporation in an open environment. Malla king named the waterspouts as Hiti. Accordingly, erstwhile rulers implemented strict rules to sustain the water supply and management systems of Hitis to the Kathmandu denizens throughout the year. The system was managed at the community, subcommunity, and household levels. The most common form of community-level institutional management was the Guthi (community trust) system. Within the organization of Guthi, each year, locals would contribute voluntary labor at the command of the community leaders and clean the stone waterspouts, canals, and ponds, and repair the conduits. During the Rana rule (1846-1951 AD), very few waterspouts were maintained. Shah queen Lalit Tripura Sundari Devi 1828 (Pradhan, 1990) gave a direct order to repair and manage stone waterspouts. The importance of stone waterspouts decreased significantly as the use of piped water started in the 1950s. More damages have been done to this traditional system once high-horse powered suctional pumps are used to pump-out underground water. In spite of this, some of the stone waterspouts and well exist even today in many places (Figure 4a).

The aquifers of the Kathmandu Valley’s watershed have different types of soils; for examples, Dystrochrepts, Haplumbrepts, Haplustalfs, and Rhodustalfs (Figure 4b). Dystrochrepts are formed from mica gneiss and schist which contains clay and primary minerals. These soils have the least morphological development on which the thinness and coarse texture of the sola accumulation may occur beneath the cambic horizons in vertical cracks in the structurally rigid, isovolumetrically weathered saprolite. Several unconfined aquifers exist within such structures. The source of clay is relatively easily weathered plagioclase (Rice et al., 1985). Haplumbrepts, Haplustalfs, and Rhodustalfs contain calcareous materials and are found along the foothills of the hillocks facilitating the process of groundwater recharging in unconfined aquifers. Haplumbrepts and Haplustalfs types of soils are found along densely populated area, where the surfaces have “Kalimati” that invites interference by humans for groundwater recharge through deep-ground injections. In the northern areas, the soil has low base saturation with a minimum horizon, but as the topography changes to a plain valley, the soil becomes compact with a thick dark horizon. In the northern region, if soils are not disturbed, groundwater recharge becomes normal, but the compaction of soil with the constructions of various structures leads to surface and sub-surface run-off, where deep water injection remains the only solution to recharge groundwaters.

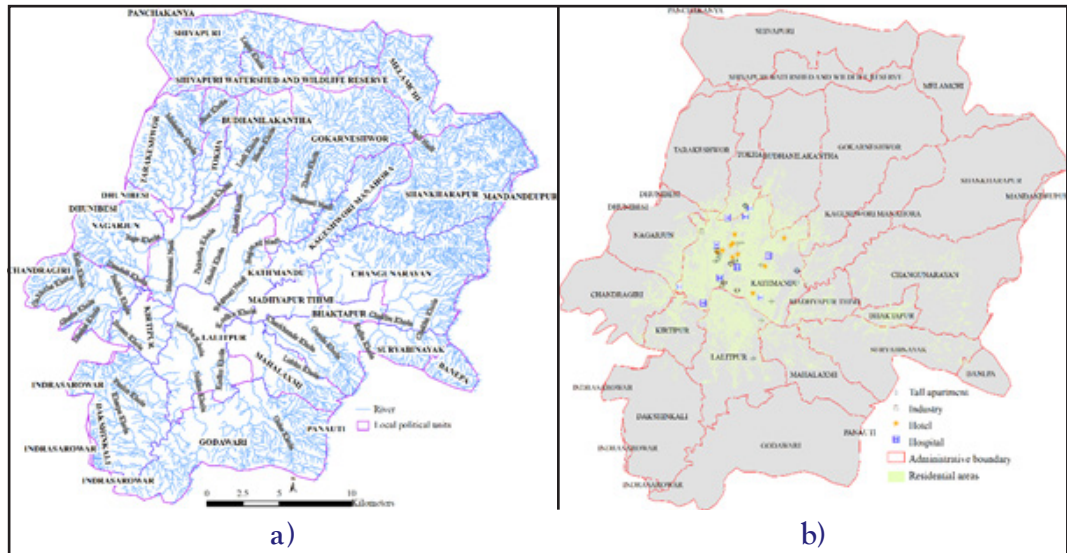
Figure 5. Kathmandu Valley: (a) River systems contributing to groundwater recharge and (b) Locations of tall apartments, industries, hotels, hospitals, and settlements concentrations where most groundwater pumping activities are confined.

The Kathmandu Valley Watershed (KVW) is drained by Bagmati river and its tributaries such as Bishnumati, Hanumante, Dhobi Khola, Manohara, Balkhu, and Nakhhu covering an area of 613 km² ranging in elevation from 1,212 to 2,762 meters above the mean sea level (Figures 4 and 5). These rivers have many tributaries, many of which are seasonal. The total river run a length of the KVW is 2,710 kilometers (km). Some are very short (0.36 km) while Bagmati has the maximum continuous length of 60 km within the delineated watershed area (Figure 5a). Within the KVW,

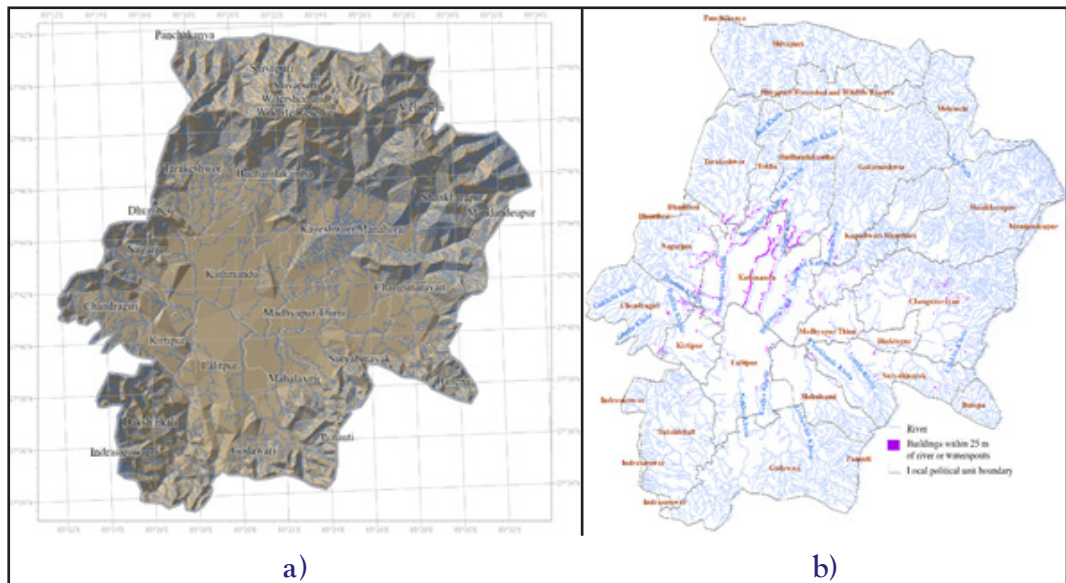
Figure 6. Kathmandu Valley: (a) Watershed with river systems, and (b) Locations where structures are built either on or above the rivers, waterspouts, or within 25 meters within water sources. These structures occupy an area of 75,3327 square meters. These structures disturb the process of groundwater recharge leading to ground subsidence (Figure 7).

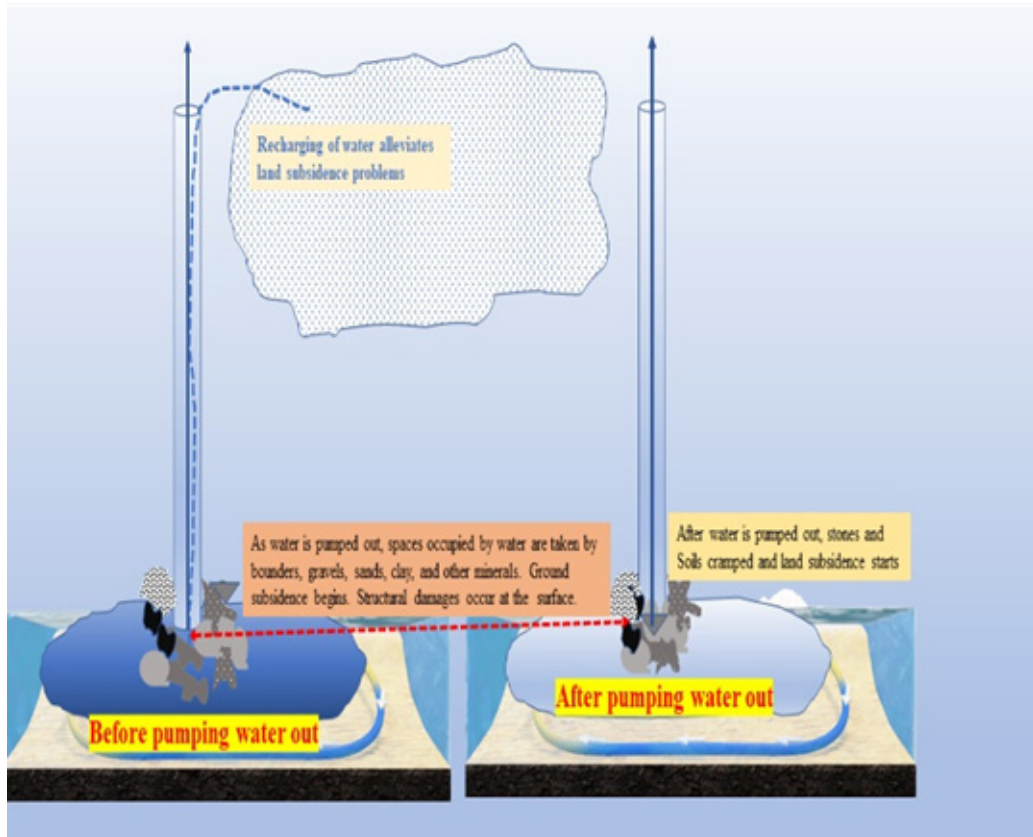
Figure 7. When water is pumped out, stones, gravels, sands, and soil particle occupy the spaces taken by these materials and land subsidence starts.

the excessive pumping of groundwaters (Bhattarai et. al., 2017; Hu et al. 2009). When excess of water is pumped, the soil and rocks naturally compact (Figure 7) (USGS, 2018, 2022). As land subsides due to the movement of gravels, sands, and boulders to occupy the vacant spaces created due to the extraction of water, it not only reduces and lowers the water levels, but also a shift in the topographic gradients occurs on the surface (Yamaguchi, 1969), which also leads to the damages to the structures on the ground. Evidence of ground subsidence have been reported from Brazil (Chaves and Lorena, 2019); Red River Basin, USA (Sabzi et al. 2019); Tokyo, Japan (Yamaguchi, 1969); Mexico (Ortega-Guerrero et. al., 1999); Saudi Arabia (Ghanim, 2019); Ravenna, Italy (Teatini et al., 2005); Bangkok, Thailand (Bergado et al., 1987); Pingtung Plain, Taiwan (Ting et. al. 2020); and China (Xu et al., 2008). These studies have revealed that land subsidence occurs due to multiple causes, of which, the diminishing of the amount of underground water and displacement of materials to replace the water have been the major causes. Bhattarai et al. (2017) from their observations between 2007 and 2010 have reported such incidences in the Kathmandu Valley. Extreme precautions are warranted to avoid further irreversible incidences of ground subsidence in the Kathmandu Valley.

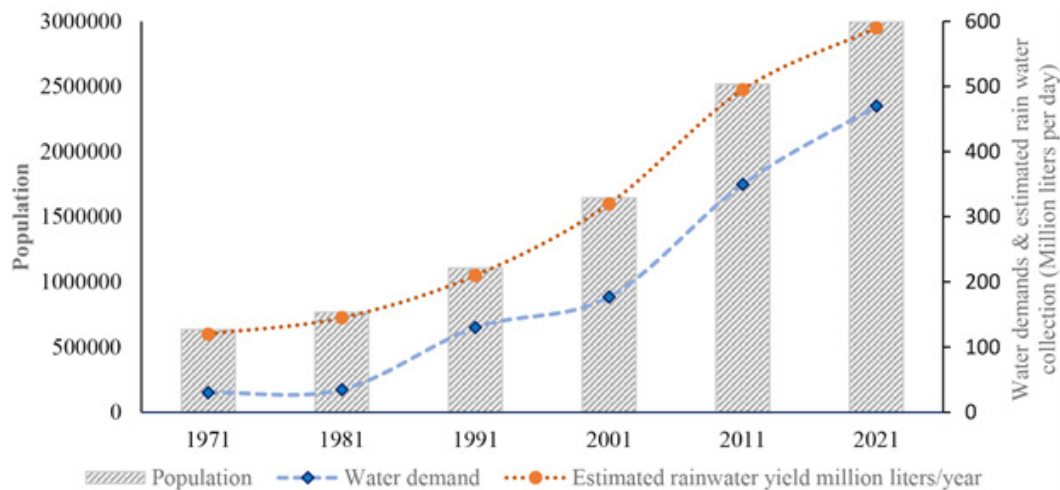
Figure 8. Population growth, daily demand for drinking waters and potential for harvesting rainwaters. Source: Shrestha et. al. (2022), Prajapati et al. (2017), Shrestha (2009) and CBS (2022)

- d. Based on these assumptions, we have estimated the possible amount of rainwater that could be harvested each year in the urban areas of the Kathmandu Valley (Figure 8).

At a time when many of the stone waterspouts in the Valley have died, and the Valley water supply has been unreliable, the Kathmandu Valley might benefit from harvesting rainwaters for two objectives: recharging the depleting water to avoid land subsidence (Figure 5 and 7), and supplementing the water needs of the Kathmandu Valley's residents (Figure 8).

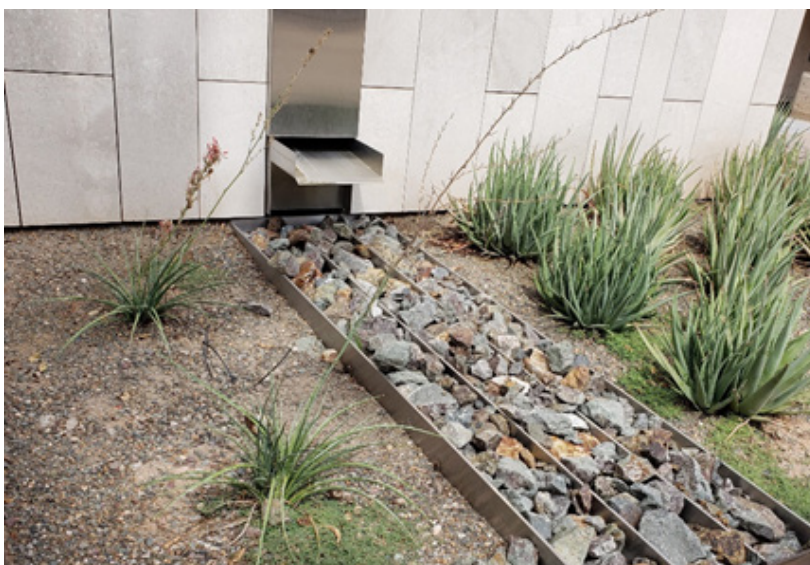
Figure 9. Redirecting rainwater to landscape irrigation in Tempe, AZ, USA. Photo by the authors.

passed an ordinance requiring commercial developments to meet 50% of landscape irrigation water using on-site rainwater harvesting (City of Tucson, 2008). As rainfall is low and water demand is high in Arizona, many cities are crafting and implementing regulations and guidelines to encourage water harvesting and use the water for irrigating landscaping and urban agriculture on site, and for other gray water uses such as for creating ponds and fountains on-site, and to use the stored rainwater for aesthetic reasons and for acceptable household uses. Many cities in the US require or advise the creation of rain gardens (which are irrigated by rainwater) for landscaping the site and prohibit the use of potable water to irrigate landscaping except when they are being established. The International Green Construction Code (IgCC), (IgCC 2018) generally prohibits the use of potable water to irrigate urban gardens, turfs, and landscapes except during the plant establishment period. An example of redirecting rainwater collected through the building roof to irrigate on-site landscaping is provided in figure 9.

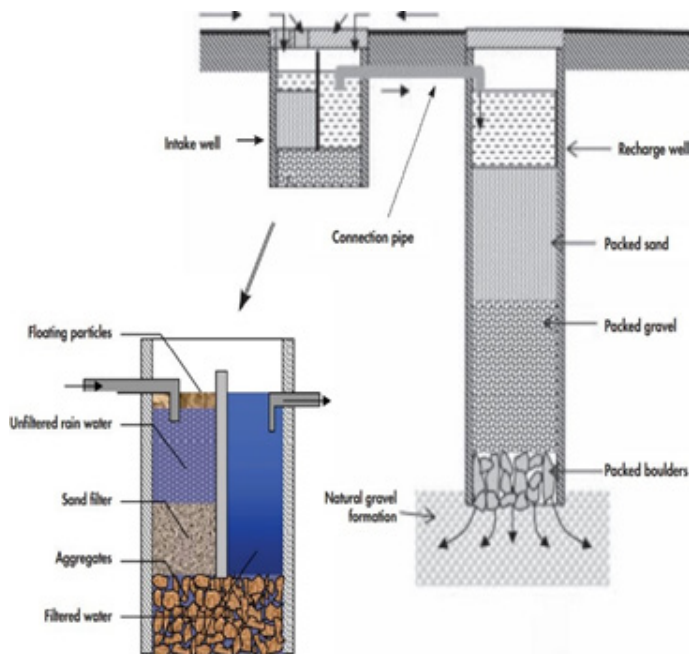
Figure 10. Cross-section of recharge pit for shallow ground water. Modified and adapted from Shrestha (2009).

Shrestha (2009) along with local communities of Patan at the initiation of the UN-HABITAT have devised a scheme (Figure 10) to recharge groundwater. This scheme may be helpful in mitigating the issues of ground subsidence which has been observed in the Kathmandu Valley caused by
