PERFORMANCE ANALYSIS OF MASONRY BUILDING WITH COURTYARD

Abstract

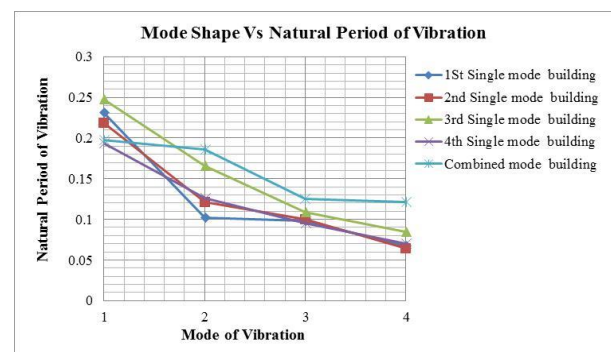
Fig 7 Mode shape Vs time period of vibration.

In time history analysis or in the dynamic analysis of the building first mode of vibration is the major time period of vibration. In general building in first mode vibration is more critical than other mode. However, sometimes in other mode also the buildings are highly deflected. In this system the buildings are in conglomeration forming L-shape. The buildings are just constructed side by side and there is no any interconnection system between the adjoining buildings. While comparing the graphs of the single/individual modeled building versus combined modeled building, the combined modeled building's first natural period of vibration is less in all four single modeled buildings (fig 7). The combined modeled building first mode and second mode of vibration shows it resonates at a low frequency. But in third mode and fourth mode of vibration, the natural period of vibration is higher than single modeled building. It represents that the combine modeled building responses like a flexible building compared to the single modeled building (Fig 3). From the results it can be concluded that the buildings in conglomeration reinforce each other and helps to resist the earthquake damage.

(Note: - Solid line for individual form/modeled building and broken line for combined form/modeled building)

The natural period of vibration shows that the building in conglomeration time period is the average of the buildings, which is very near to the two large buildings and also is at the corner of the conglomeration. From the combined and single modeling, it is found that the time period of vibration of the combined mode is more. It shows that the building gets flexibility and strength in

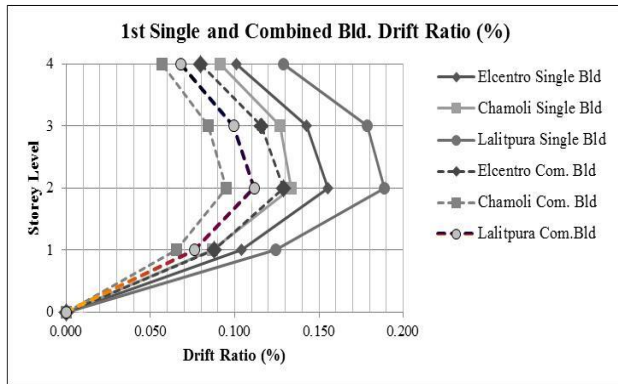
Fig 8 1st Single and combined building drift ratio graph.

The inter story drift percent from Chamoli time history and Lalitpura time history shows that the effect of these two function is more than the El-centro time history for this first building (Fig 8). Amplification is about double in individual form. Also in case of second building, the input acceleration shows prior effect in individual case than in the combined case (Fig 9). The Chamoli time history and Lalitpura time history amplify the drift ratio about 45% more in individual form, where the El-centro time history function only resonant the drift ratio about 20% more than the combined form. But in case of third modeled building the amplification is more than 60% in combined form than the single form (Fig 10). The

conglomeration. The drift ratio of buildings in individual form is remarkable greater about 50% than the building in conglomeration. This also proves that there is great advantage to build buildings in conglomeration if the local effects can be reduced by adopting proper connection, same floor level and similar height of building. However there is also some of the disadvantage in building houses in courtyard form. The corner of the house is more susceptible to get damaged during earthquake than other houses. As in an individual form building, the corner part is damaged in earthquake due to the load concentration, less support and out of plane behavior. Same theory is also applicable in the courtyard typed masonry building.

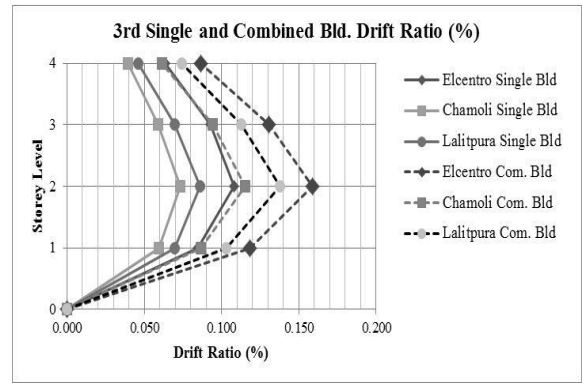
Fig 10 3rd Single and combined building drift ratio graph.

third building is in the corner of the conglomeration. Corner part of any building is very vulnerable in dynamic loading. The building constructed in corner of conglomeration is more likely to collapse on dynamic loading than other adjacent building. The corner building shall be constructed more strong than the same building constructed in separate form. Other buildings in conglomeration get strength due to the arrangement than the same building in separate form. The capacity of the building is compared with the table of the code FEMA-356-2000 (Table C1-3).

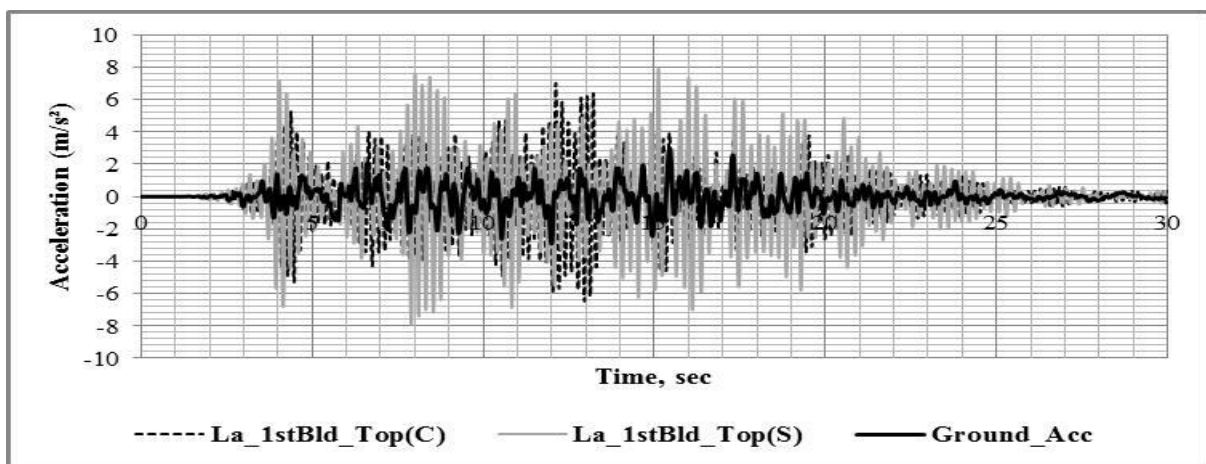
Fig 12 Time history graph of Lalitpura earthquake at 0.3g for 1st building.

Similarly, in case of Lalitpura the individual case building gets highly accelerated almost all the time. The third building which is at the corner of the conglomeration shows different response in the given time history acceleration. This building response in all the time history is greater in combined form than in the individual case. Combined case gets highly accelerated almost all the time in all three time history input. The fourth building is peculiar too. It is the second largest building in our conglomeration. Amplification is not significant, and there is almost similar amplification in individual and combined case. The individual building accelerates more with respect to combined building.

(Note: - Dark solid line for actual ground acceleration in 0.3g, faint continuous line for individual form/modeled building and broken line for combined form/modeled building)

Time history curves of all the three buildings, 1st, 2nd and 4th, show that the spectral acceleration of the individual form of building is twice the combined form building. In case of the 3rd building, the combined form building spectral acceleration is one

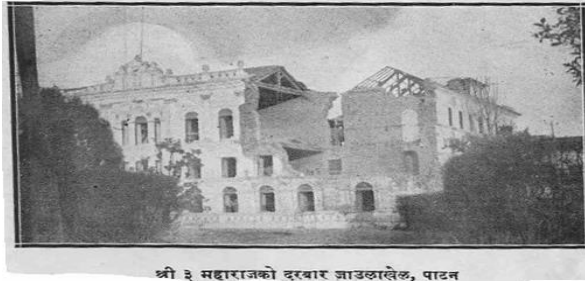
Fig 14. Jaulakhel Darvar after 1990 BS earthquake.

and half as much as than the individual form. This also justifies that the corner building should be strongly constructed. The historical data also shows that the corner buildings are damaged in earthquake. From one of the pictures published in the historical book Nepal- Behar Earthquake, by Rana (1936), the corner of courtyard building had collapsed due to earthquake (Fig 14).
