EARTHQUAKE RISK MANAGEMENT ON A COMMUNITY LEVEL - A CASE STUDY OF BHAKTAPUR DURBAR SQUARE

Libas Phaiju¹, Rameswor Shrestha², Suraj Shah²

Abstract

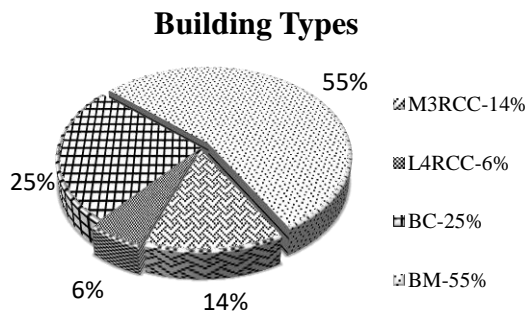
Fig. 6. Building types in study area.

M3RCC -RC type of more than three stories with/without masonry wall

(L4RCC) -RC type of less than four stories with/without masonry wall

(BC)-Brick masonry buildings with cement mortar joints

(BM)-Brick masonry buildings with mud joints

There are 14% (Fig. 6, 15 numbers out of 107) M3RCC buildings (Fig. 7) in the study area. The initial plan such as the size of columns and beams was probably for three-storey buildings. However, existing RCC buildings are extended up to four to six stories, without strengthening the columns and beams. These buildings have strong beam but weak column.

There are only 5.6% (Fig. 6, 6 numbers out of 107) L4RCC buildings (Fig. 8) in the study area. These L4RCC buildings would have the proper size of columns and beams.

It has been found that there are about 25.23% (Fig. 6, 27 numbers out of 107) BC buildings (Fig. 9) in

There are 55.14% (Fig. 6, 59 numbers out of 107) BM buildings (Fig. 10) which comprise more than half of the buildings in the study area. This category

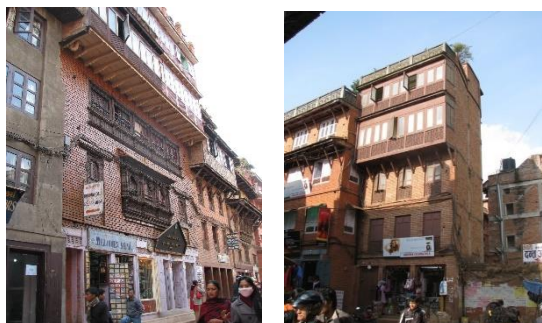
Fig. 7. More than 3-storey buildings of RCC

M3RCC buildings are vulnerable to earthquakes not only due to above mention activities but also due to poor workmanship, absence of site supervision by qualified professional, lack of inspections for quality control, good design and construction practices during any stage of construction by owners, designers, local officials or supervisors.

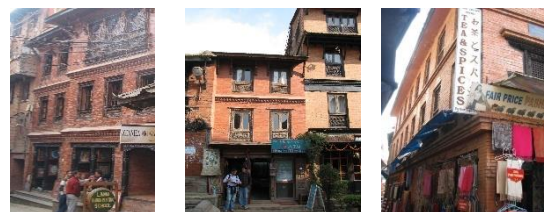
Fig. 8. RC type of less than four stories (L4RCC)

If correctly designed and constructed to the draft NBC, with correct beam depth and reinforcement bars, it would resist an earthquake to some extent. But there are very few numbers of such types of building in the study area. According to the economic conditions of the owners, construction contracts are customarily handled on a personal basis. Quality control problems are likely to occur when owners make their own arrangements for resources and construction materials and pay the workers on a piecemeal basis.

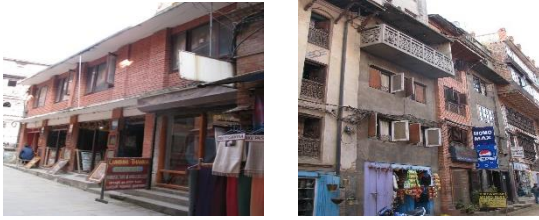
the study area. This type of building is generally with rigid RC slabs for floors and roof. They are improved in structural strength when compared with brick masonry buildings with mud joints.

Fig. 9. Brick masonry with cement mortar (BC)

However, they are still poor regarding horizontal rigidity due to poor workmanship and lack of structural consideration regarding the joints between walls, floors and roofs. Although buildings of this type less than four stories constructed with suitable workmanship and good wall balance may see safe, those that are more than four stories are highly vulnerable during a great earthquake. Instead of discouraging this activity, the construction of such building is increasing in the study area. People prefer construction of RCC building to traditional building because of lack of skilled masons or craft persons/workmanship, cost of carvings too expensive, lack of availability of materials like wood/mud, peer pressure, lack of awareness.

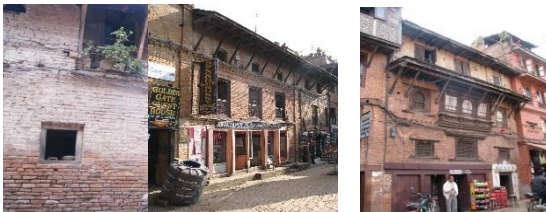
Fig. 10. Brick masonry buildings with mud joints (BM)

also consists of traditional Malla and Rana period buildings. These traditional building are made of brick, mud and wood. These buildings have simplicity and symmetry in plan and elevation and have similar building material, detailing and architectural style.

These building (Fig. 10) have very poor horizontal rigidity because of the low bond strength, high absorption of moisture at the mud joints, and the wooden floors and roofs. During a great earthquake, BM buildings of less than three stories or higher seem very fragile not only due to addition of extra floors to obtain space required for increasing family size and vertical division to accommodate individual families but also due to Lack of damp proof course which decreases the lifespan of old buildings.

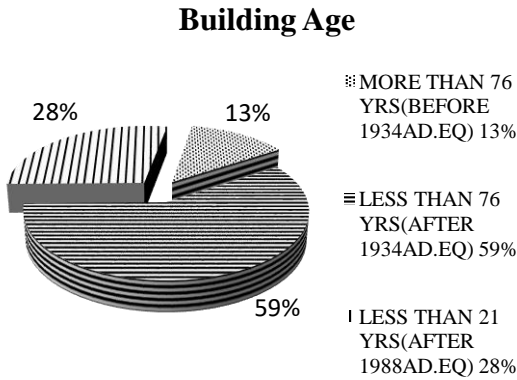
The age of the buildings (Fig. 11) in the study area has been categorized on the basis of the great earthquake 1934 A.D and earthquake 1988 A.D which severely effected in Kathmandu valley. It has been found that most of the buildings i.e. about 59% buildings in the study area are of less than 76 years old. They were built after the great earthquake 1934 A.D and there are about 28 % buildings which are of less than 21 years old built after the 1988 A.D earthquake. But still there are 13 % buildings in the study area that are of more than 76 years old i.e. built before the 1934 A.D great earthquake. It is clear that maximum buildings were collapsed during 1934 A.D earthquake. It has been observed that there are major structural cracks in almost all those buildings (13%) which have survived after 1934 AD great earthquake. 50% of the buildings which were constructed after 1934 AD great earthquake have minor cracks on the walls.

Fig. 11. Building age

It is not that old buildings are more vulnerable to future earthquake while newly constructed buildings are less vulnerable. Old traditional building maintained frequently with good workmanship and advice from technical expertise may be less

vulnerable to earthquake which is proved by the survival of 13 % buildings in the study area built before the 1934 A.D great earthquake whereas the new buildings constructed with poor workmanship and without technical advice from expertise may be more vulnerable to future earthquake.
